SUMMARY REPORT

Client:	Needham DPW	Dates:	10/21/2019 to 10/25/2019
Contract:	Rosemary Lake Dredging		
Contractor:	Maverick Construction Co., Inc.	Inspector(s) on site:	Caroline Armstrong, Laura Krause

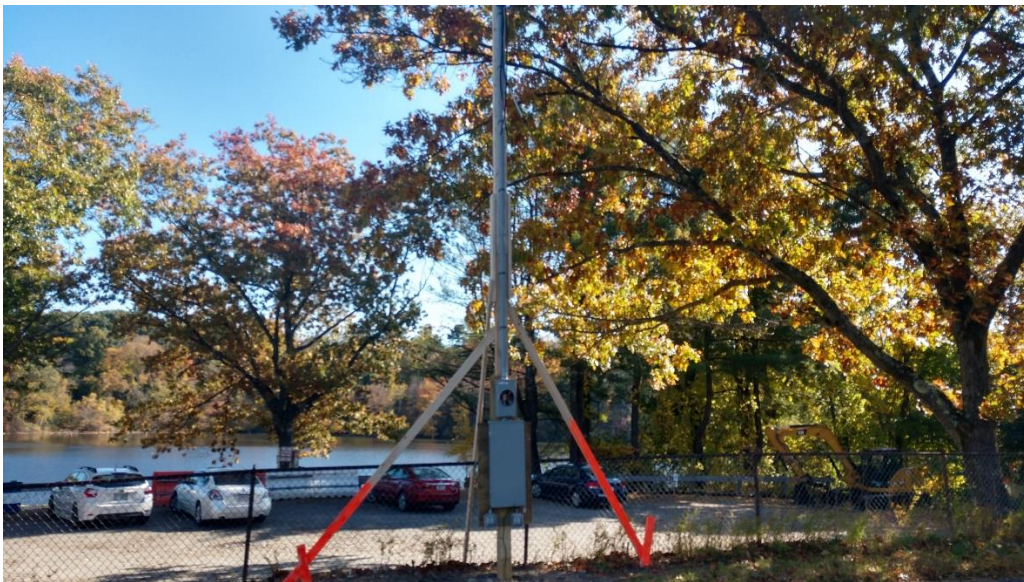
Temporary electric service pole

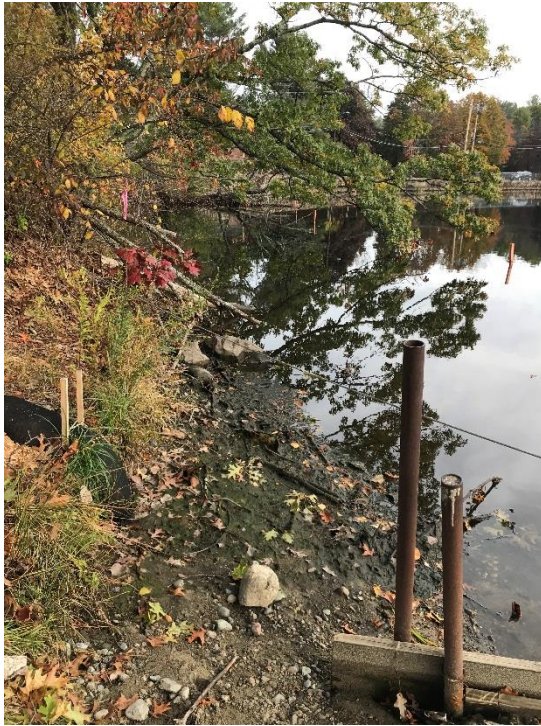
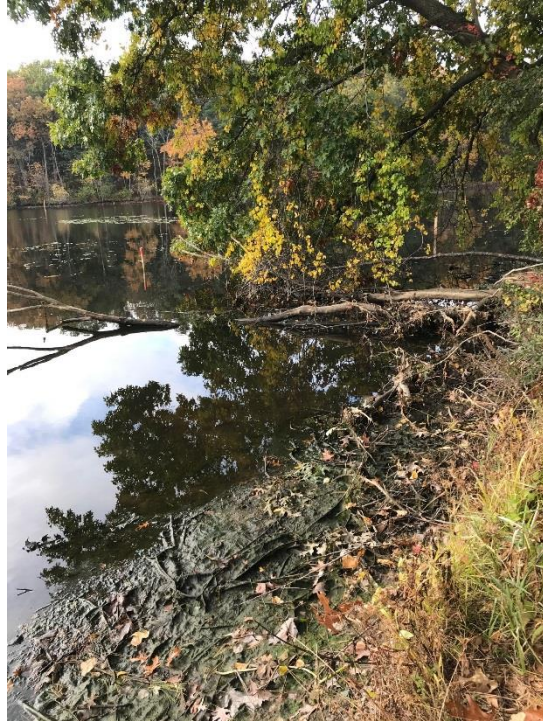
**Staging Area – Drawdown progress on Tuesday (13 days after initiation of drawdown).
(10/18/2019)**

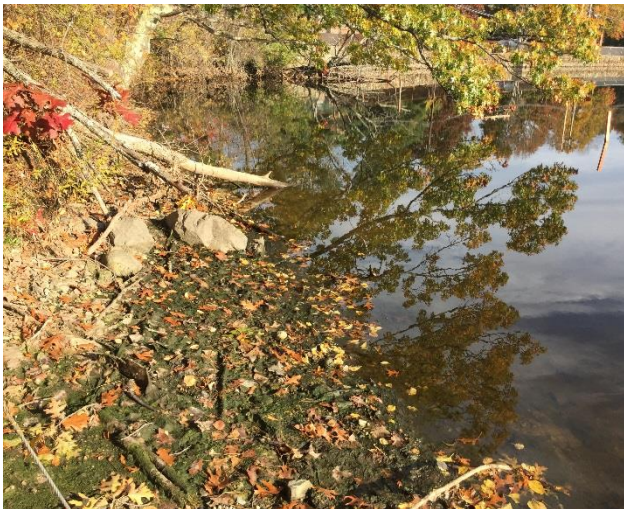
View east of staging area

**Staging Area – Drawdown progress on Friday (16 days after initiation of drawdown).
(10/25/2019)**

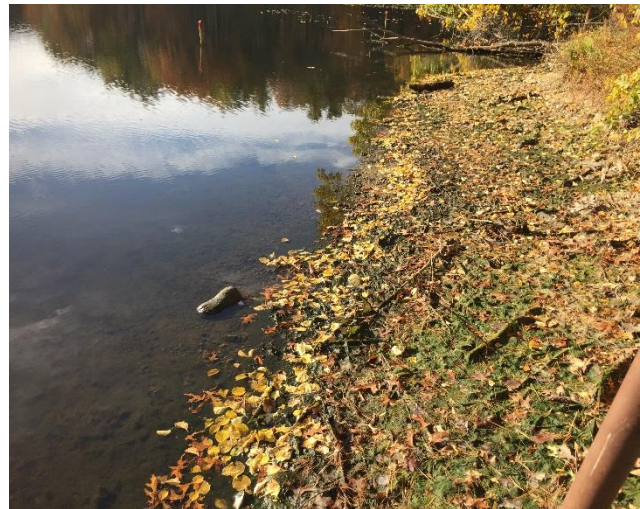
View west of staging area

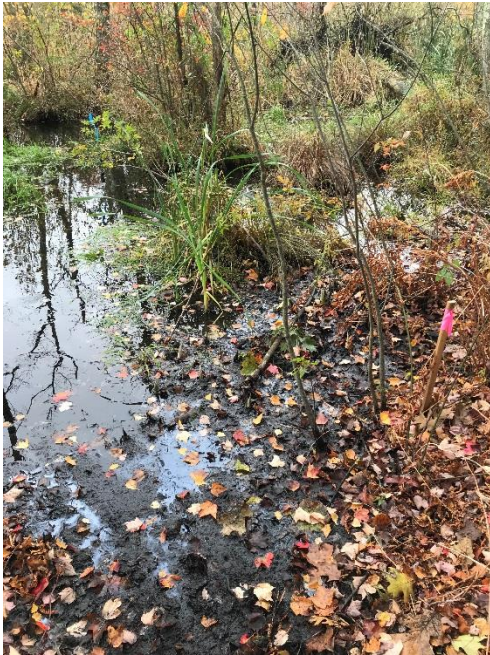
Station 5.1 and 5.2 (Whalen Property) – Edge of Bank shown. Turbidity, velocity, and sediment depth readings taken on Tuesday (13 days after initiation of drawdown). (10/22/19)

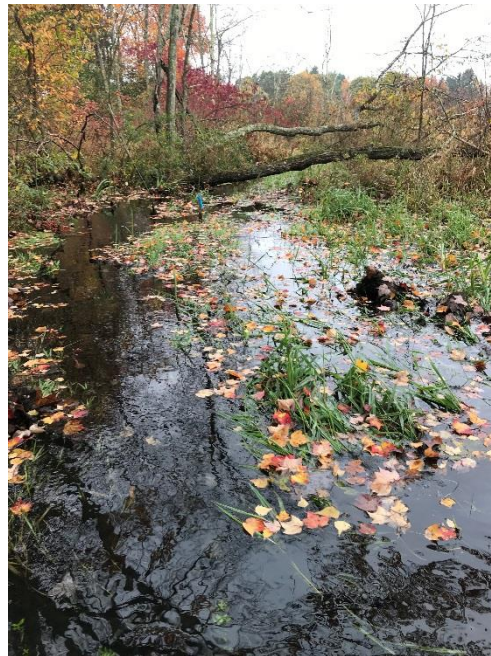
Station 5.3 (Whalen Property) – View downstream from Station 5.3 at Whalen property. Turbidity, velocity, and sediment depth readings taken on Tuesday (13 days after initiation of drawdown). (10/22/19)

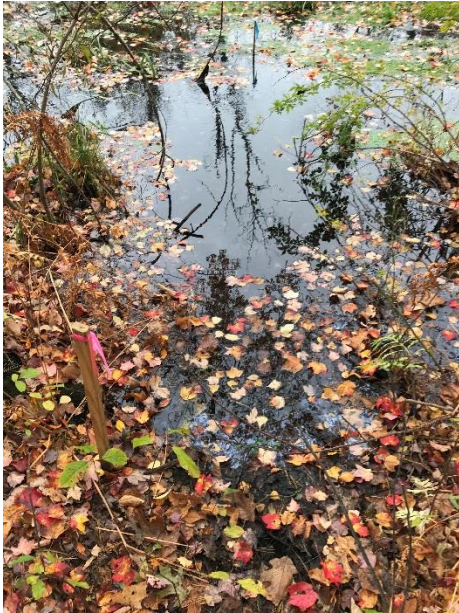
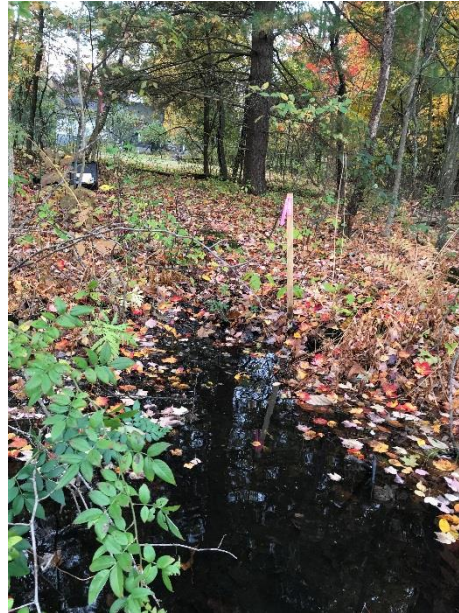
Station 5.4 (Whalen Property) – Edge of Bank shown. Turbidity, velocity, and sediment depth readings taken on Tuesday (13 days after initiation of drawdown). (10/22/19)

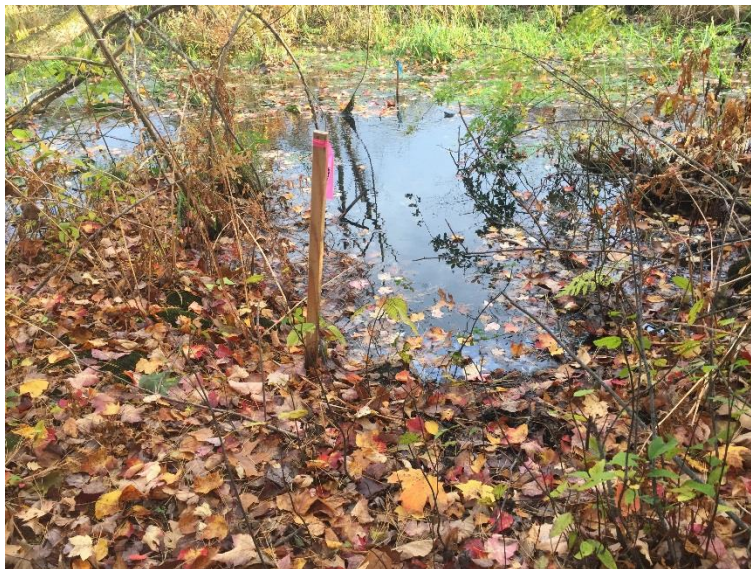
Station 5.4 (Whalen Property) – Edge of Bank shown. Turbidity, velocity, and sediment depth readings taken on Friday (16 days after initiation of drawdown). (10/25/19)

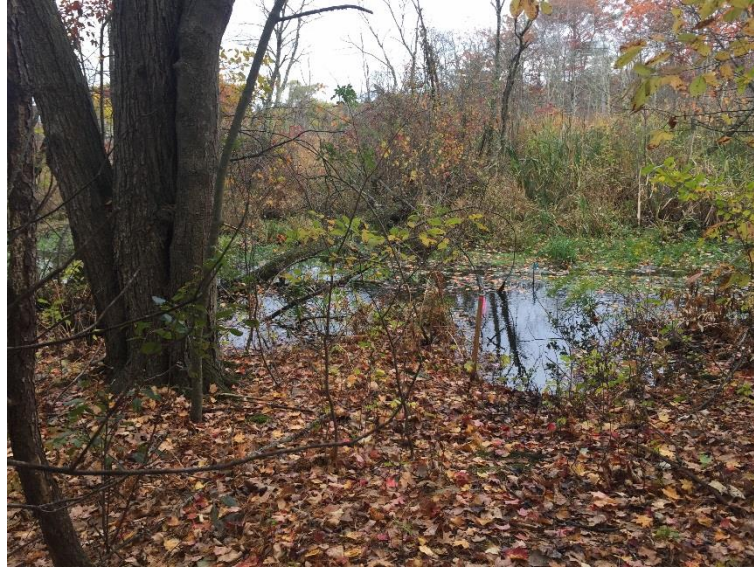
Station 5.4 (Whalen Property) – Edge of Bank shown. Less vegetation than Summer months. (10/25/19)

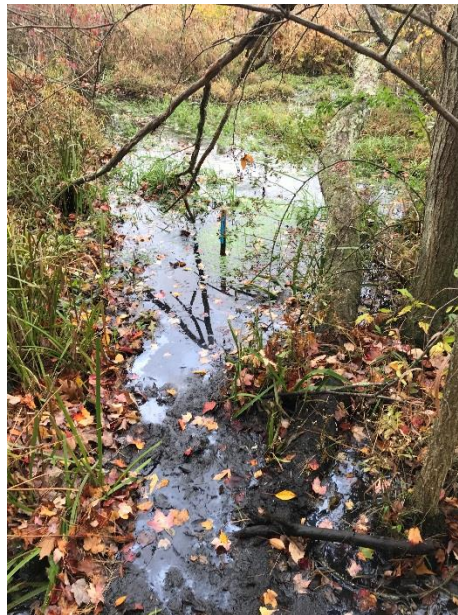
Station 5.5 (Whalen Property) – Turbidity, velocity, and sediment depth readings taken on Tuesday (13 days after initiation of drawdown). (10/22/19)
